# DAMP & MOISTURE ASSESSMENT REPORT

| <b>Property:</b> | 24 Example Lane, Sampleton, Worcestershire, WR1 1AA |
| <b>Inspection Type:</b> | Buyer — Pre-Purchase Damp and Moisture Assessment |
| <b>Inspection Date:</b> | 25th June 2026 |

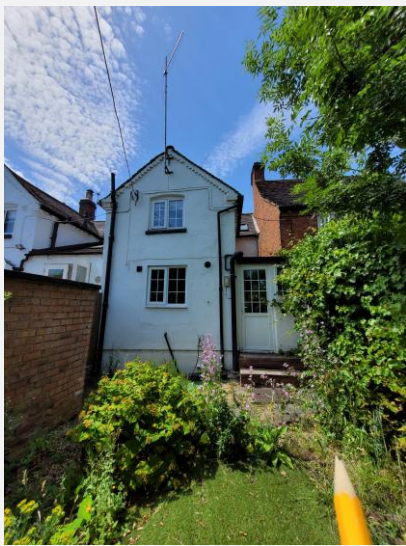
**Photo 1** — *Rear of property*

Rear elevation: The rear elevation is rendered and painted. Rainwater goods to the rear appeared visually satisfactory. Rear ground levels appeared acceptable with no obvious evidence of external ground levels bridging the wall base in a way that would contribute to internal dampness. A rear garden area was present and vegetation was noted, though this did not appear to be causing any immediate concern to the fabric of the building at the time of inspection.

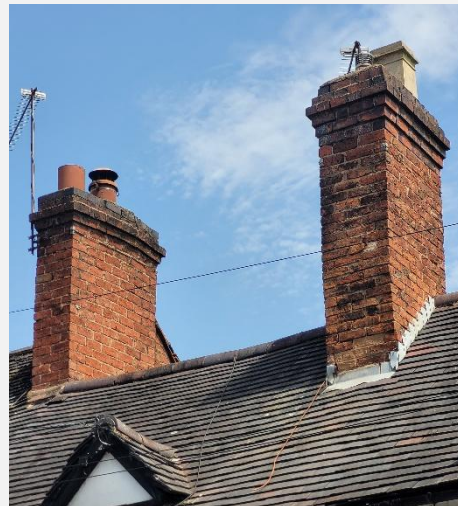
**Photo 2** *Chimney check*

Front elevation: The property fronts directly onto the road with no setback. The painted render to the front elevation appeared generally satisfactory. Rainwater goods to the front elevation appeared visually intact and serviceable. The roof coverings were inspected from ground level and appeared generally satisfactory. Two chimneys are present and both appeared visually serviceable at the time of inspection. No significant defects were observed from ground level.

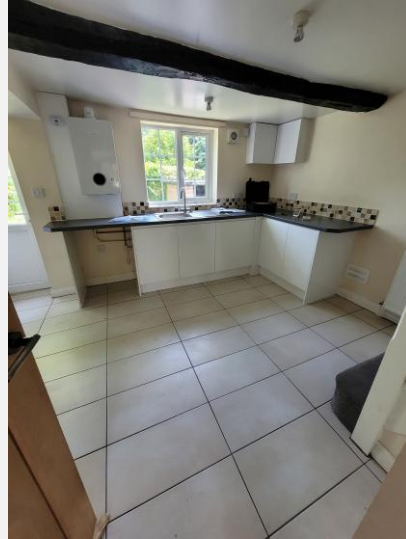
**Photo 6** — *Kitchen*

Kitchen: The kitchen was clean, dry and presented no evidence of active moisture ingress. Humidity readings were acceptable. The wall and floor surfaces appeared in satisfactory condition with no active moisture or staining observed. Under-sink plumbing was visually inspected: no obvious leakage was observed, though minor historic marks were noted on the cabinet base. The kitchen extractor fan was tested and found to be operational.

Trickle ventilation within the property is limited, which is not unusual in a building of this age. The kitchen extractor fan was found to be operational at the time of inspection. No mould growth was observed anywhere within the property.

As a sensible housekeeping improvement, the kitchen extractor fan is recommended for replacement with a humidity-controlled (humidistat) model. This will improve background moisture management in the kitchen without requiring any structural works.

| Work Needed | Description | Priority | Likely Trade / Further Advice |
|---|---|---|---|
| <b>Kitchen extractor fan replacement</b> | Replace existing kitchen extractor fan with a humidity-controlled (humidistat) model. Sensible housekeeping improvement to assist background moisture management. | <b>2</b> | Electrician or general contractor |

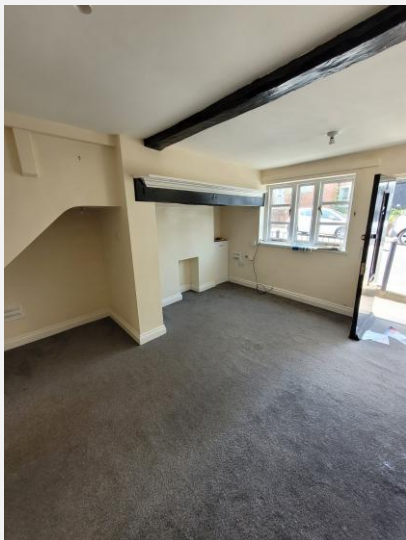
**Photo 7** — *Living room moisture checks throughout*

Living room: Surface readings of approximately 50% were recorded immediately above floor level at the base of the fireplace breast, with rapid reduction through the wall above. No significant pin meter support was recorded. No mould growth was observed and no damp odours were detected. Exposed structural timbers were present in the living room ceiling and were tested with the pin meter: no elevated moisture readings were recorded and no evidence of active timber decay was found.

| Location | Reading | Classification | Notes |
|---|---|---|---|
| Living room — fireplace base (surface) | ~50% | Minimal damp (surface) | Rapid reduction with height. No significant pin support. |

Normal solid-wall moisture characteristics — living room: The low-level surface readings at the base of the fireplace breast are characteristic of older solid-wall construction, where residual moisture or hygroscopic material at the base produces elevated surface readings. The rapid reduction with height and the absence of significant pin meter support indicate that this does not represent active rising damp.

| Work Needed | Description | Priority | Likely Trade / Further Advice |
|---|---|---|---|
| <b>Monitor and general maintenance</b> | Monitor the entrance wall and living room fireplace base following purchase. If elevated readings persist or worsen, arrange further investigation. Maintain rainwater goods and pointing routinely. | <b>3</b> | General maintenance contractor as required |

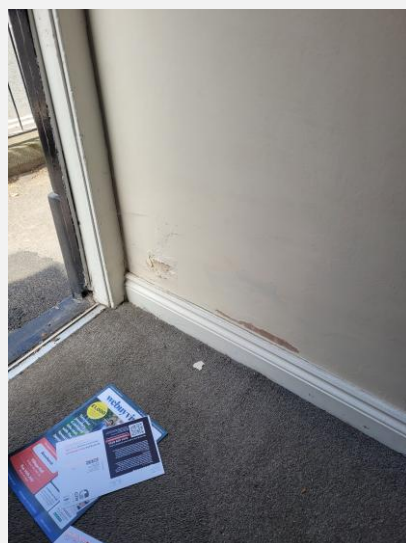
Entrance area: Concrete floor construction. A localised area of historic salt contamination was visible to the lower left-hand corner of the wall adjacent to the entrance doorway. Surface moisture readings at this location reached approximately 100% at the very base, reducing rapidly with height. Pin meter readings provided support only immediately at the base of the wall, with no meaningful pin reading through the middle or upper sections. Percussion testing identified a small area of hollow or blown plaster approximately the size of a hand at low level. No mould growth or damp odour was detected. Doors opened and closed freely with no evidence of moisture-related movement or distortion.

| Location | Reading | Classification | Notes |
|---|---|---|---|
| Entrance wall — low level (surface) | ~100% | Damp (surface) | Rapid reduction with height. Pin support at base only. Consistent with historic salts. |

Historic salt contamination — entrance wall: The localised elevated readings at the base of the entrance wall are consistent with hygroscopic salt contamination within the plaster and masonry. The salts are drawing moisture from the air and producing elevated surface meter readings. The rapid reduction in readings with height and the absence of meaningful pin meter support through the wall above the base confirm that this is a surface phenomenon rather than active moisture rising through the wall. A small area of hollow plaster was identified at low level; this is consistent with salt-related plaster deterioration over time.

**Photo 10** — *Evidence of minor salt damage — small local repair*

| Work Needed | Description | Priority | Likely Trade / Further Advice |
|---|---|---|---|
| <b>Local plaster repair — entrance wall</b> | Remove loose and hollow plaster at low level to the entrance wall (approximately hand-sized area). Allow masonry to dry. Apply a breathable lime-based plaster repair. Redecorate when fully dry. This will minimise future salt contamination affecting paint finishes. | <b>1</b> | Plastering contractor (lime-compatible materials recommended for listed building) |

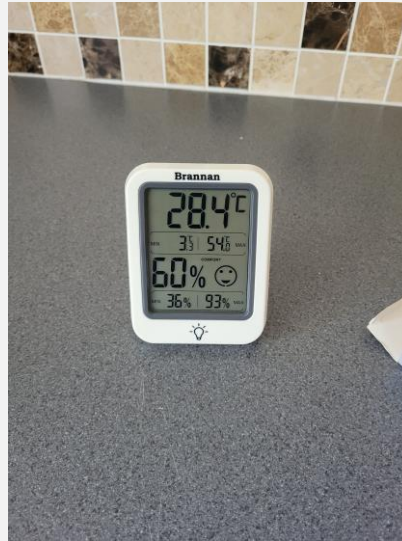
**Hygrometer Reading**   Temperature: 28.4°C   Current RH: 60%

At the time of inspection the internal temperature was recorded at 28.4°C with a relative humidity of 60% RH. This reading falls within the normal comfort range and is consistent with a warm summer day. The property was unoccupied, which means there was no active moisture generation from cooking, bathing or respiration. The environmental conditions on the day of inspection did not indicate a condensation risk and were not conducive to artificial elevation of moisture meter readings.

**Photo 12** — *Moisture and temperature readings on the day*
